**MARYLAND HISTORICAL TRUST
DETERMINATION OF ELIGIBILITY FORM**

Property Name: Mabel Brittingham House Inventory Number: S-274
Address: North side of L.Q. Powell Road, in Tulls Corner Vicinity Historic district: ☐ yes ☒ no
City: Marion Zip Code: 21838 County: Somerset
USGS Quadrangle(s): Marion
Property Owner: Unknown Tax Account ID Number: Unknown
Tax Map Parcel Number(s): Unknown Tax Map Number: Unknown
Project: Proposed Tower Site: Marion, Somerset County, Maryland Agency: Maryland Dept. of Budget and Management
Agency Prepared By: A.D. Marble & Company
Preparer's Name: Stephanie Foell and Stacey Streett Date Prepared: 3/22/2005
Documentation is presented in: Proposed Tower Site: Marion, Somerset County, Maryland
Preparer's Eligibility Recommendation: ☒ Eligibility recommended ☐ Eligibility not recommended
Criteria: ☐ A ☐ B ☒ C ☐ D Considerations: ☐ A ☐ B ☐ C ☐ D ☐ E ☐ F ☐ G
Complete if the property is a contributing or non-contributing resource to a NR district/property:

Mabel Brittingham House

Maryland Historical Trust State Historic Sites Inventory Form

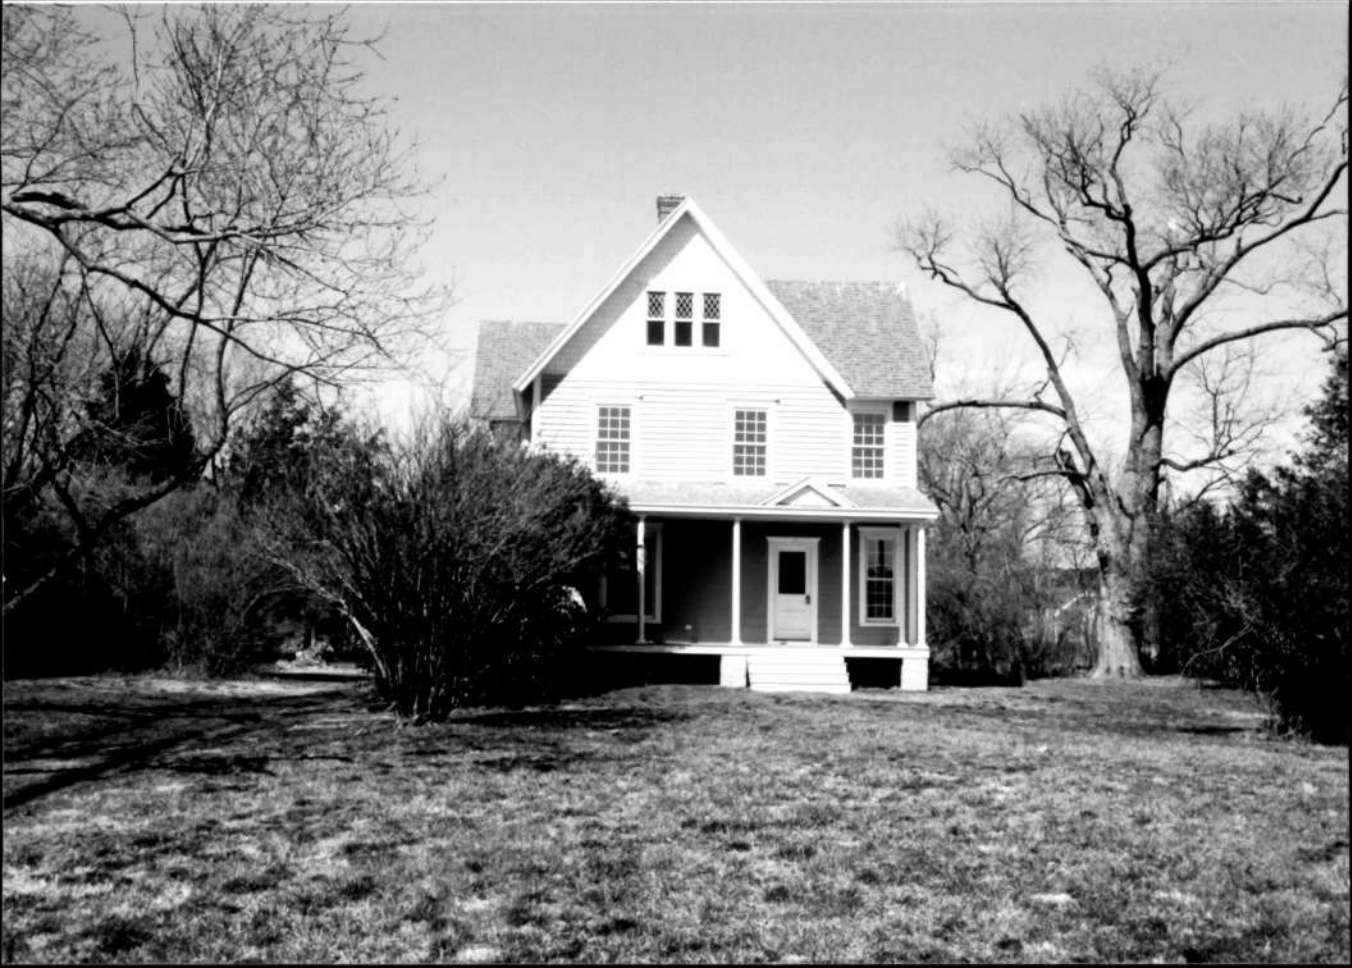
1/5

Facade, taken from north side
of L.Q. Powell Rd.

A full-width, one-story, shed-roof porch is located on the façade. It is supported by thin, Tuscan columns. The asymmetrical façade also contains an off-center entrance bay. A small, pediment is located on the porch roof above the entrance bay. Multi-pane, sash

Windows, which were previously single-pane, flank the entrance door. Three multi-pane windows are located on the second story of the façade. Centered within the front gable of the upper half story is a tripartite window with diamond-patterned, colored-glass panes in the upper sash and a single-pane in the lower sash. Throughout the building, windows are topped with projecting cornice moldings.

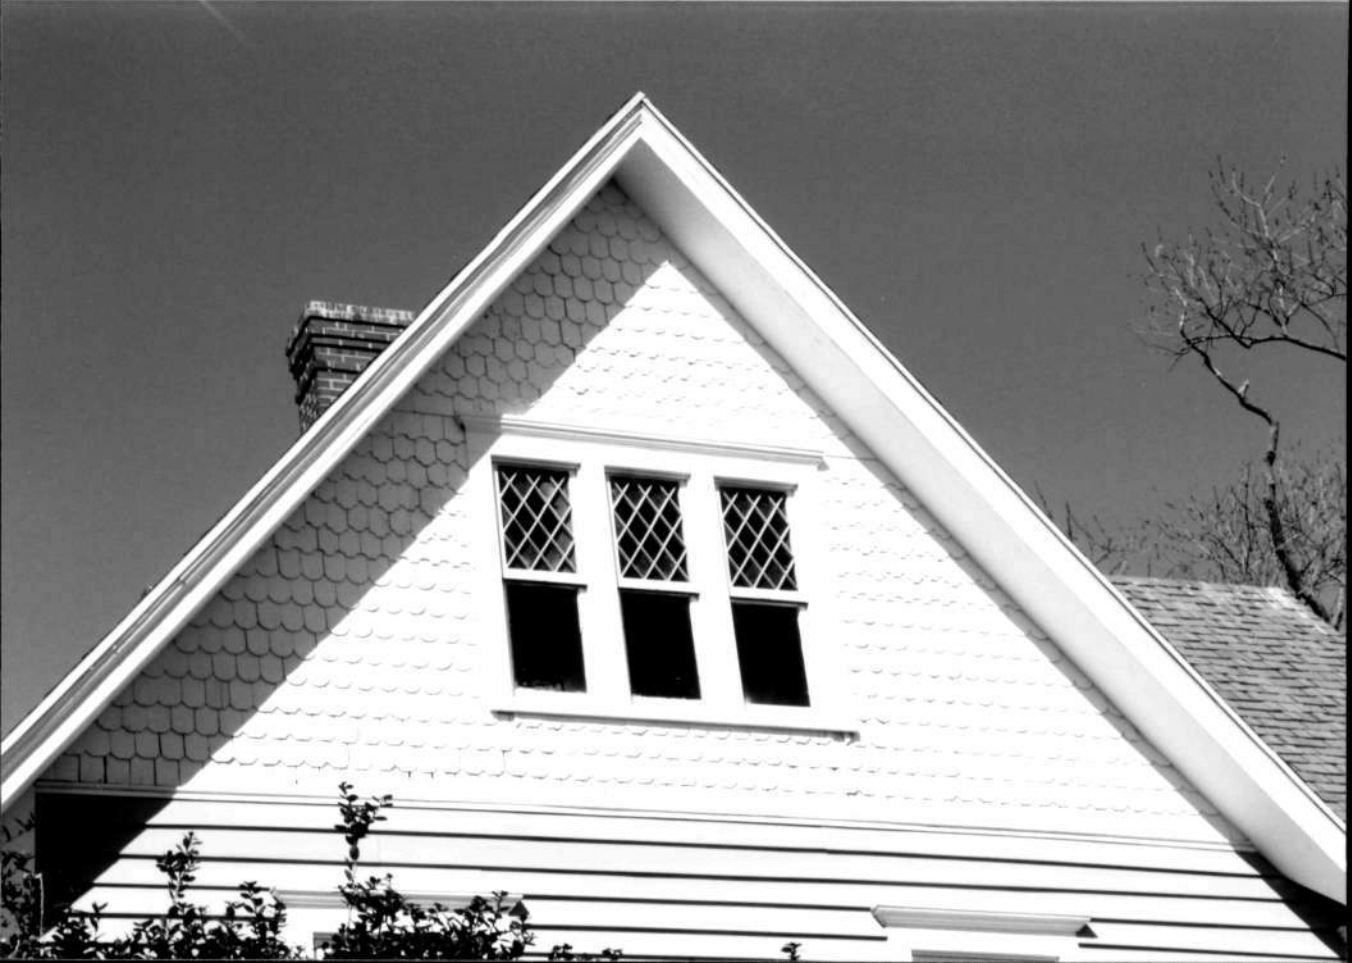
2/5

Detail of front gable, facade

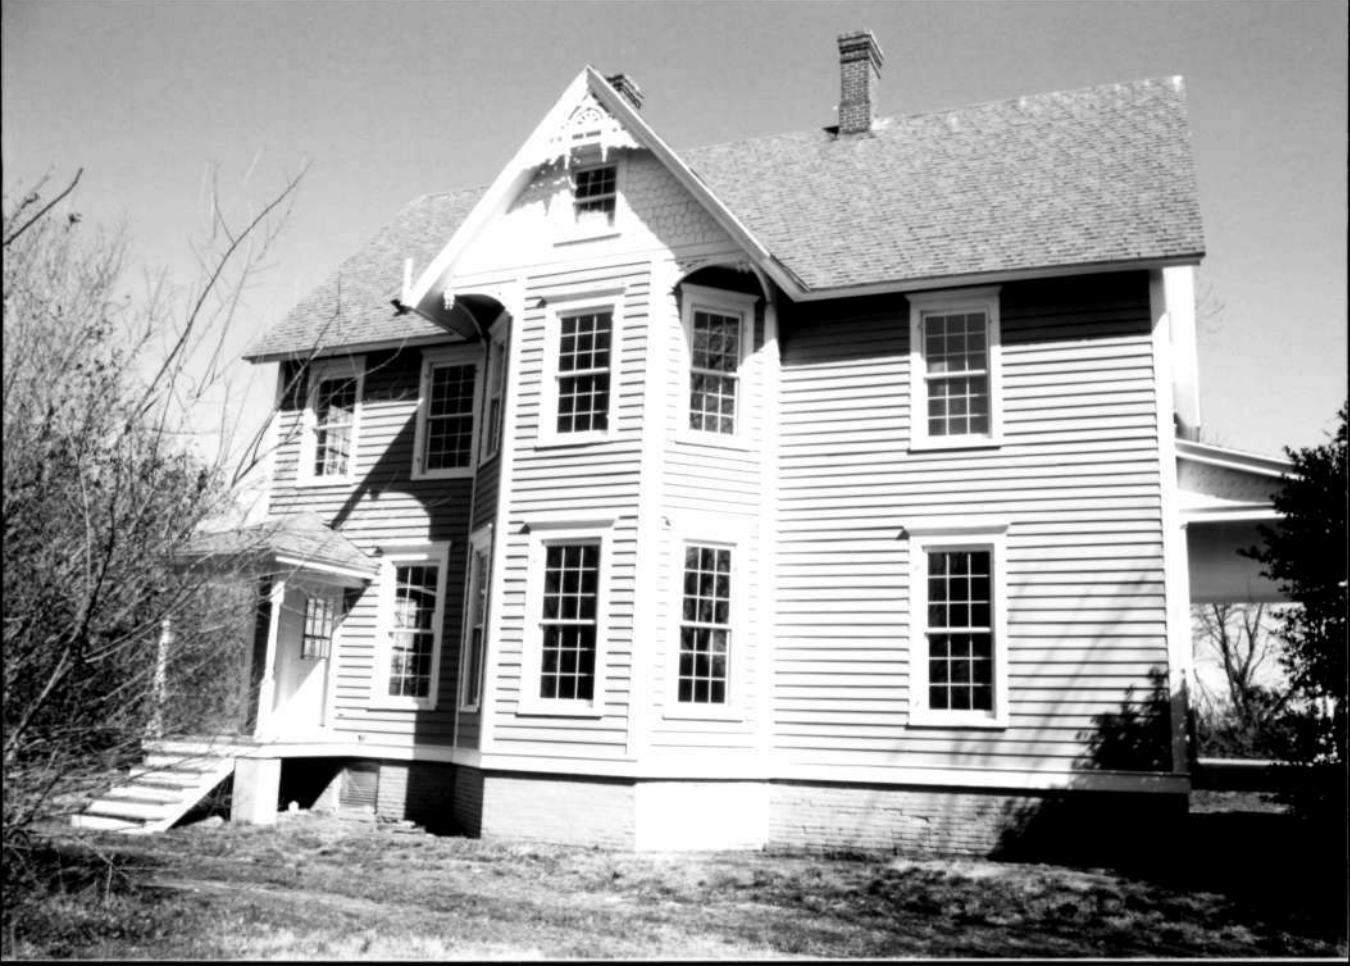
3/5

west elevation

The west elevation contains equally impressive architectural details. A three-bay projection extends from the building. This form is commonly found on Eastern Shore residence constructed during the late nineteenth and early twentieth century, although it is usually a feature on the façade. The projection is capped with a steeply pitched gable. Fish-scale shingles are located in the gable area, and decorative Victorian-era sawnwork is located in the apex of the gable and also directly beneath the gable. An entrance porch with a hipped roof is supported by the same slender Tuscan columns that are found on the façade.

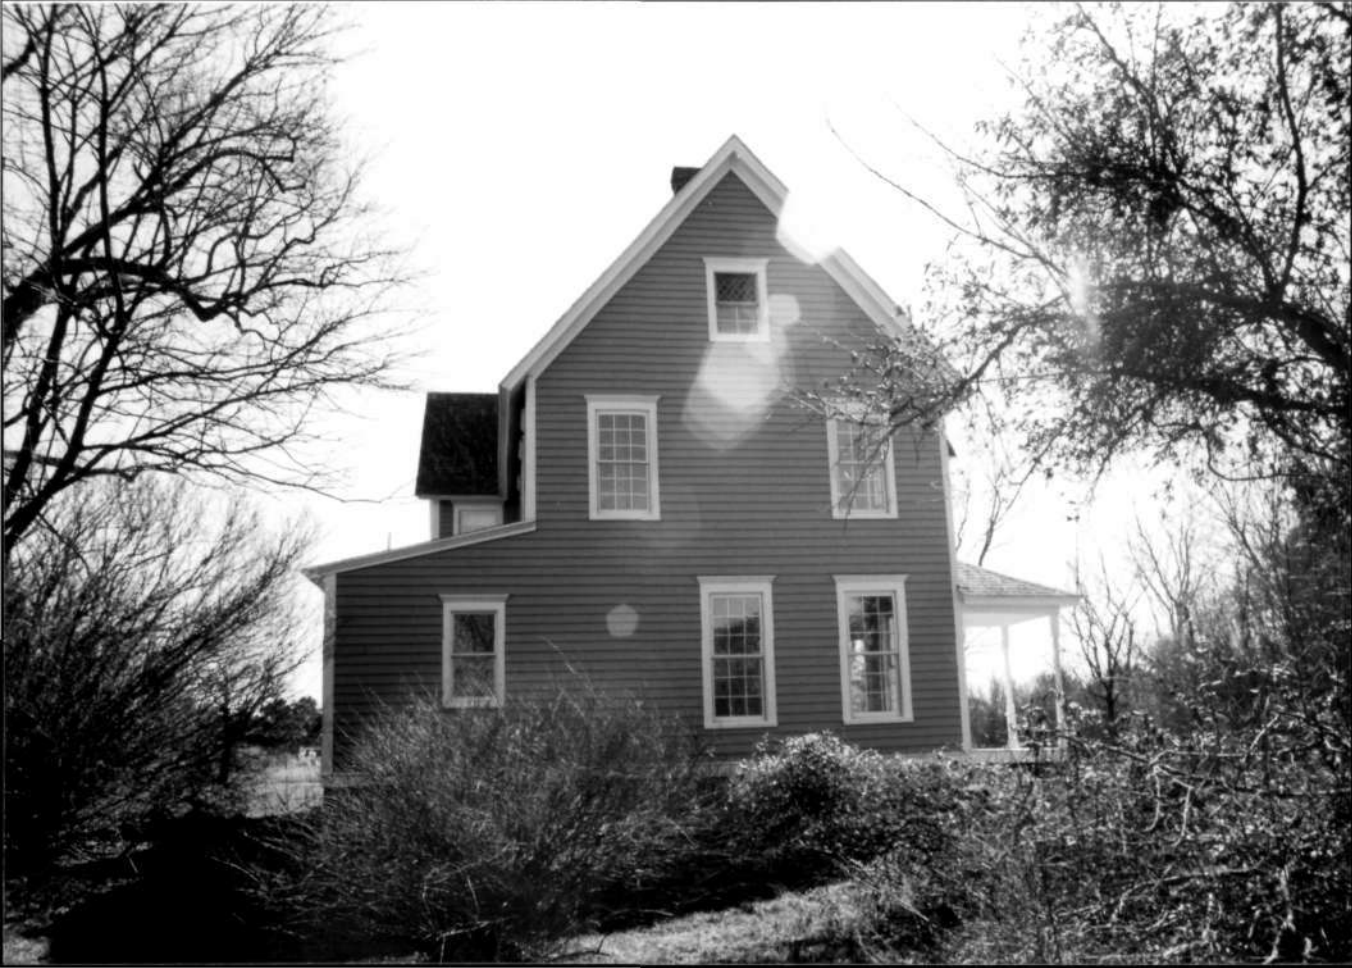
4/5

North elevation

The north (rear) elevation contains irregularly spaced six-over-six, replacement windows. A window with diamond-shaped panes is located in the gable area. The east elevation contains a single-story, shed-roof addition.

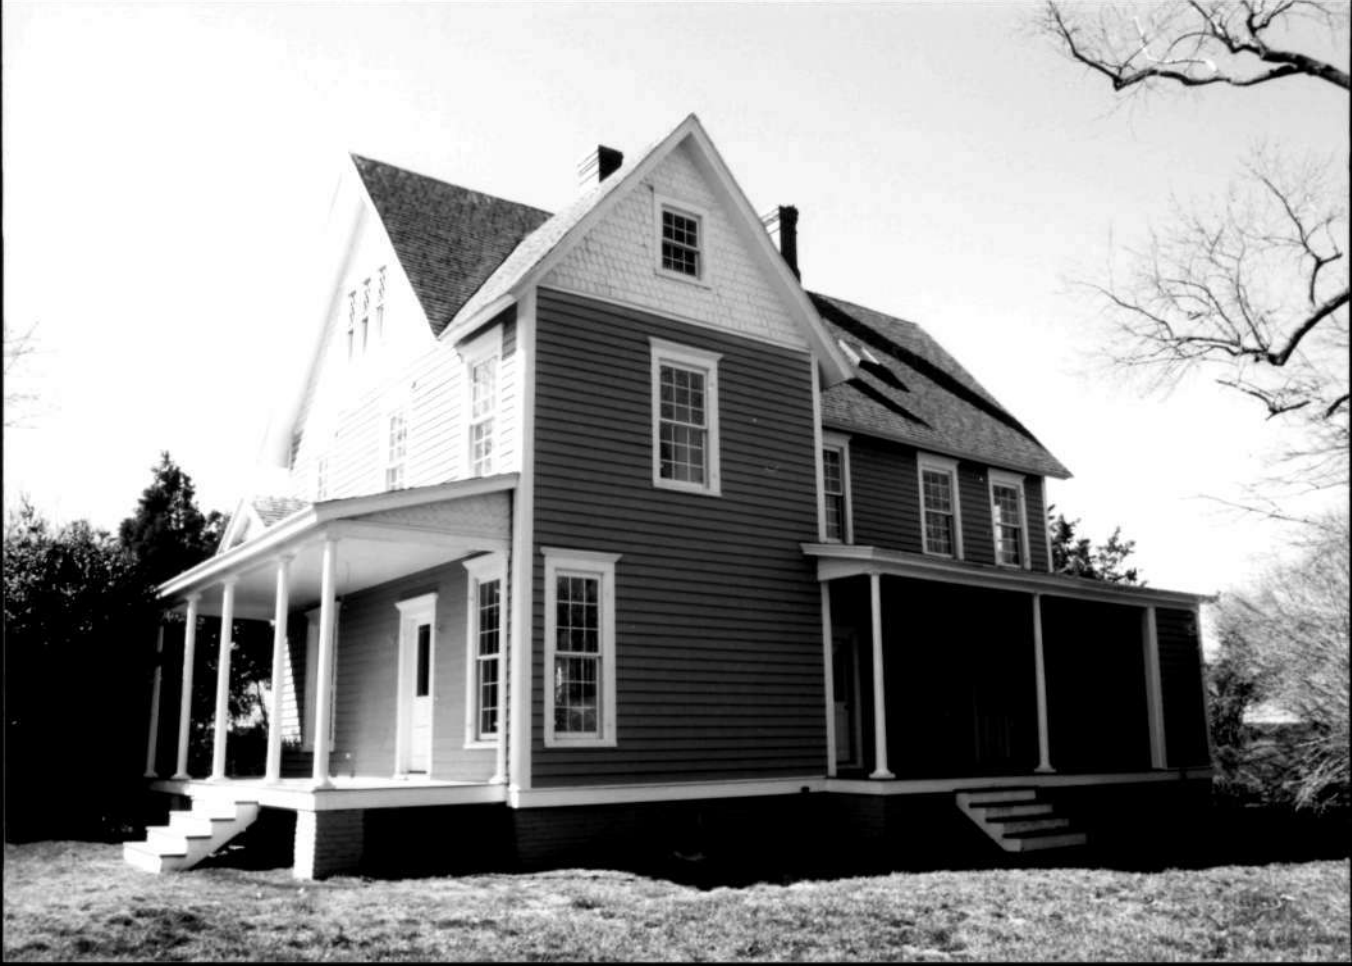
6/5

East elevation

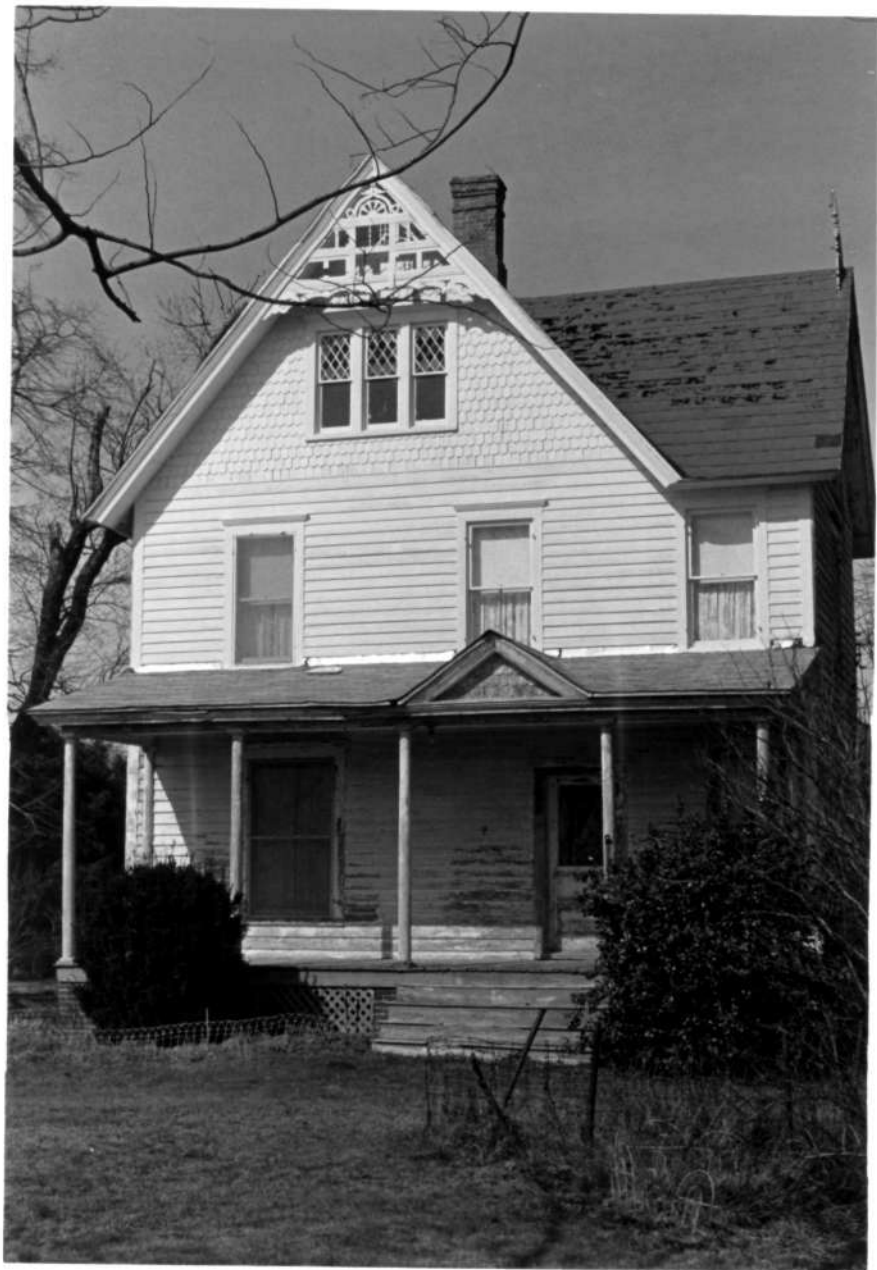
South Elevation

The south facade is an asymmetrical elevation with the entrance located in an off-central bay of the main house. The door is glazed above the lock rail and paneled below. A single-pane sash window is located to the left (west) and right(east) of the entrance bay, and the second floor is lighted by similar windows. The upper gable is sheathed with fishscale shingles and decorated with an elaborate design of sawnwork. Centered within the gable is a tripartite window with diamond pane upper sash and single-pane lower sash. A single-story shed roof porch supported by thin Tuscan columns covers the first floor and is distinguished by an off-center front gable that is covered with fishscale shingles.

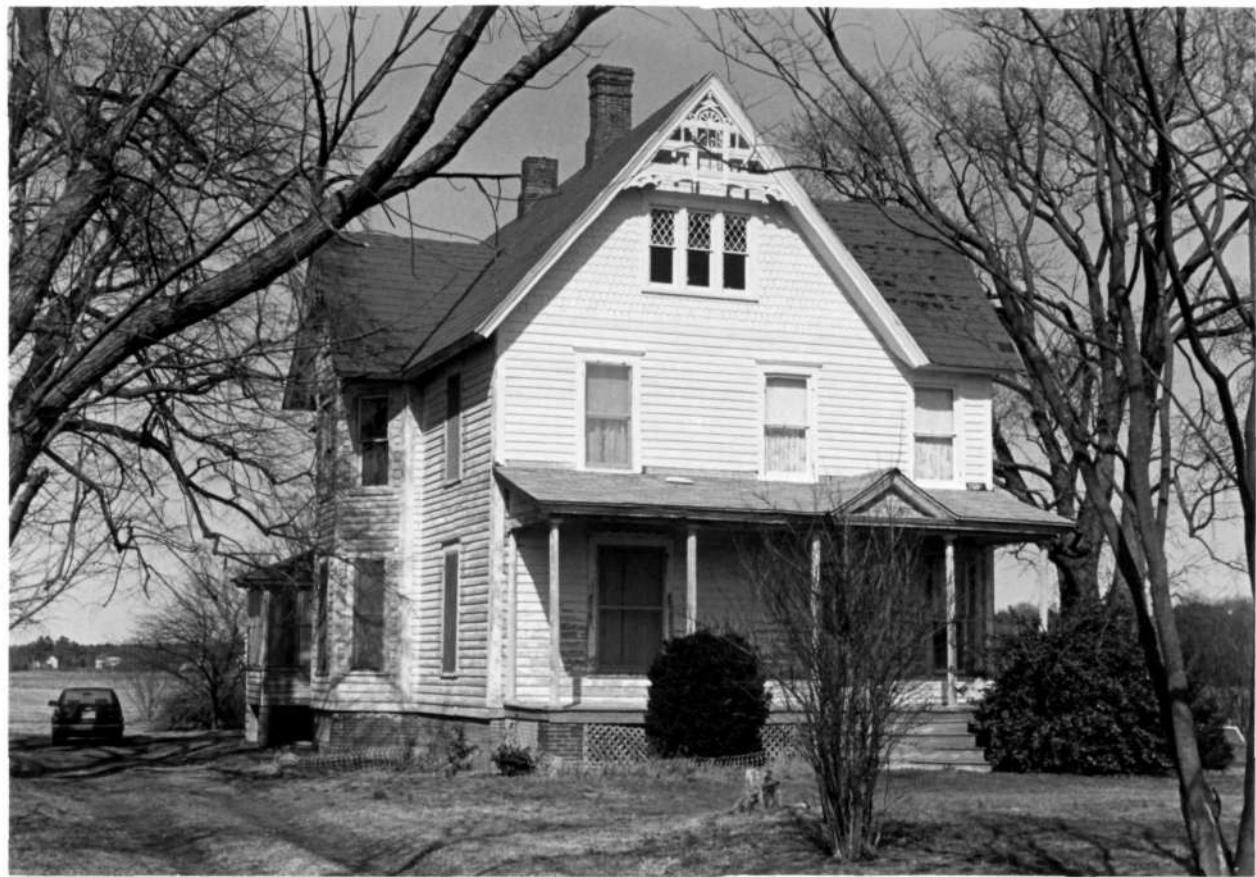
Mabel Brittingham House S-274
Near Tulls Corner, Somerset County
South Elevation
4/85, Photographer, Paul Touart
Neg/Md. Historical Trust
